DEPARTMENT OF TRANSPORTATION**DIVISION OF ENGINEERING SERVICES**

Contract #: 04-0120F4Cty: SF/ALA Rte: 80 PM: 13.2/13.9File #: 69.28**WELDING INSPECTION REPORT****Resident Engineer:** Pursell, Gary**Address:** 333 Burma Road**City:** Oakland, CA 94607**Report No:** WIR-003870**Date Inspected:** 09-Sep-2008**Project Name:** SAS Superstructure**OSM Arrival Time:** 630**Prime Contractor:** American Bridge/Fluor Enterprises, a JV**OSM Departure Time:** 1530**Contractor:** Zhenhua Port Machinery Company, Ltd (ZPMC), Changxing Island **Location:** Shanghai, China

Bay 7: OBG - Floor Beam Sub Assembly

Bay 8: Tower Diaphragm

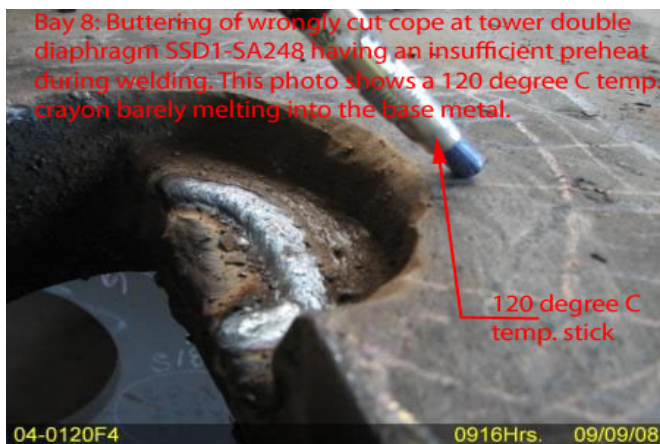
This QA observed ZPMC welder, ID #045133 utilizing the SMAW Process in the 2G/3G position with a 4.0mm diameter Excalibur E9018M H4R to weld buttering on one of the wrongly cut cope on tower double diaphragm SSD1-SA248 per T-WR171. In this buttering, the preheat of the plate being welded requires 160 degree C per WPS-485-SMAW-2G/2F-REPAIR 1 but during verification it was found insufficient. This QA initially used a 180 degree C temperature crayon to check the preheat which it did not melt. This QA used 120 degree C to check the preheat in which it barely melted as shown on photo below. With this infraction, it was added to the above incident report that was issued against ZPMC.
